Guidelines for the masonry quality evaluation in built heritage

G. Cardani¹ and L. Binda¹

¹ Politecnico di Milano, Department of Civil and Environmental Engineering, Milano, Italy

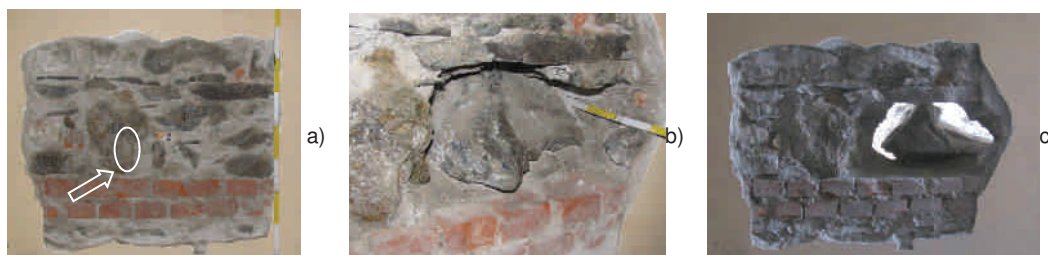
Figure 4: Inspection HSP- I5-6 at the first floor: three phases of the removal of a large stone used as “diatono”.

The example here showed (Figs. 4 and 5) is referred to the masonry of the St. Paul Hospital in Savona, where there was no correspondence between the prospect texture and the cross section of the masonry walls (Cardani et al. 2012). The XIX cent. ex-hospital of Savona (Italy) is a three storey masonry building, built in 1860, that has gone out of use since many years, waiting for repair strengthening and functional reconversion. The building is characterized by an irregular stone masonry walls.

The prospect of the masonry showed an irregular distribution of roughly cut stones of variable dimension (larger than 30 cm), bricks and wedges, with a grey lime mortar of a good quality. Smaller stones during the disassembling revealed to be larger in the depth and well stuck, showing two layers well interlocked with no voids. In several cases some “Diatoni” were found in half of the sections inspected (Figs.3-4).

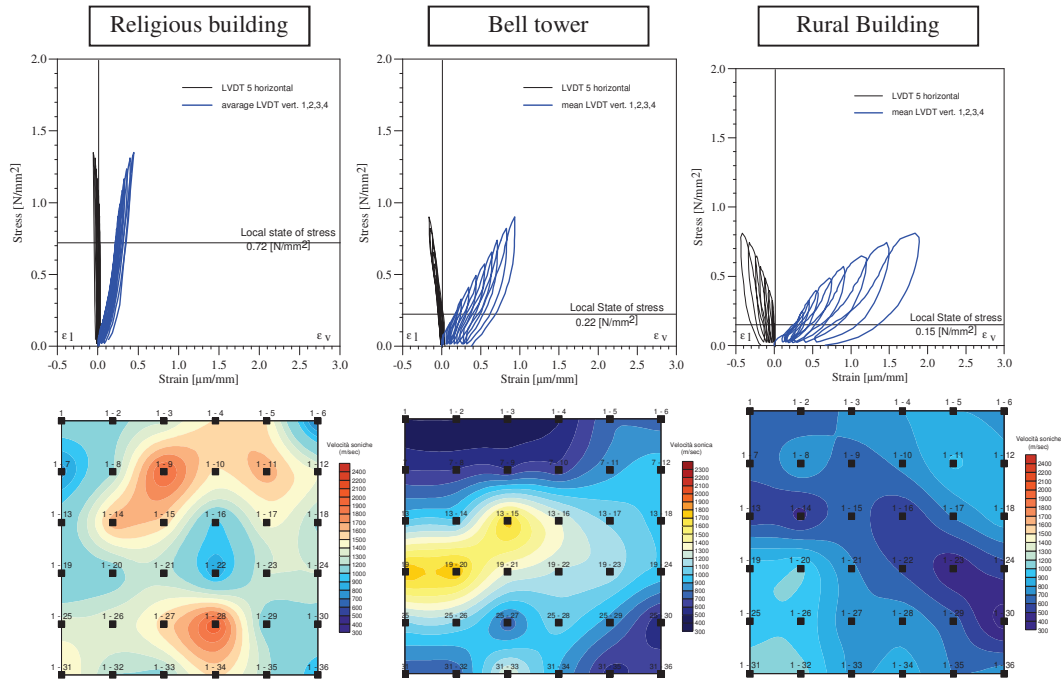
Figure 6: Results of double flat jack tests and sonic pulse velocity tests carried out on a same stone masonry (same materials) but of different building typologies of Campi Alto di Norcia (Perugia) [Cardani 2004].

The NDT sonic pulse velocity test is based on the generation of elastic waves in the frequency range of sound (20 Hz-20 kHz), by means of mechanical impulses at a point of the structure. In the case of masonry, due to its heterogeneity, the pulse velocity represents a qualitative characteristic of the masonry. The velocity is influenced by the composition of the masonry as well as by the presence of inhomogeneities, voids and deteriorated areas, as well as the number of intersected mortar joints. A velocity reduction corresponds to an increase of mortar joints or voids or to cracks presence. Higher velocity peaks states higher density of the materials and in stone masonry could represent the presence of a "diaton". It is better to carry out the test by direct transmission on a grid of measurements points that covers the area analysed later on with the double flat jack test (Fig. 6).

In figure 6 the results of the tests with single and double flat jack carried out on some sample buildings of Campi di Norcia (Perugia, Italy) are reported, where the masonry materials were always the same, while the

texture was different. Results pointed out the differences in behaviour of masonry belonging to important buildings or complex structures (church or the bell tower) in comparison with private buildings. In particular, it is possible to see that both sonic velocity and flat jack results are in agreement.
